Manhole Inspection Summary

Manhole # S710__015MH

Insp Date: **4/14/08 12:45 PM**

Location Address: **6720 Duluth Ave.**

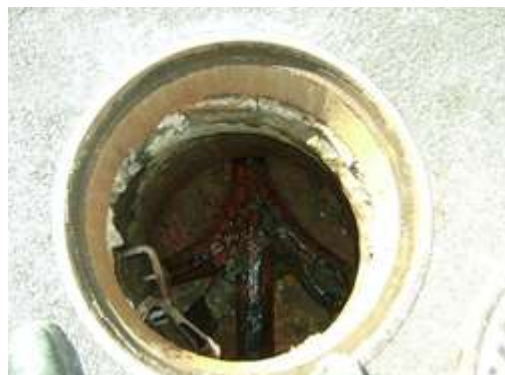
Top View

Comments **CRACKED PIPE SEALS ON INCOMING AND OUTGOING LINES. INFILTRATION EVIDENCE ON BARREL WALL FROM UNDER FRAME.**

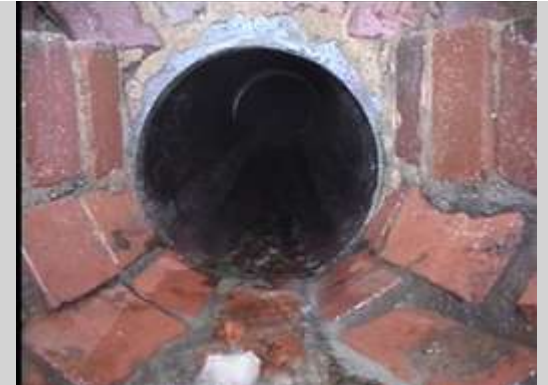
12 O'Clock Outflow

Pipe Height: **8.4** (in.) Rod and Bar (Angled)
Pipe Material: **Clay** ☐ Pipe Lined
Invert Depth: **8.92** (ft.) Flow Characteristics: **Slow**
Deposits: ☒ None ☐ Mud ☐ Sludge ☐ **Debris** ☐ Grease
Silt Depth: (in.) Deposits Extent:
Infiltration: **None** Pipe Seal Cond: **Sound**

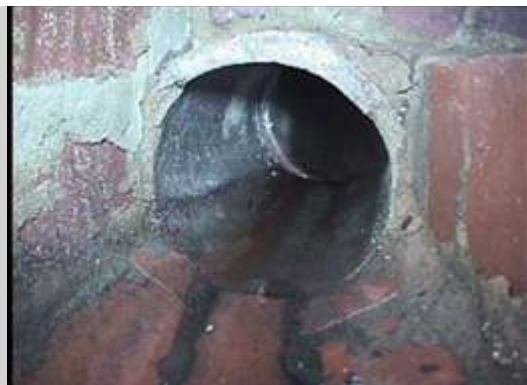
9 O'Clock Inflow

Pipe Height: **6** (in.) Rod and Bar (Angled)

Infiltration: **None**
